Dredging Research Technical Notes

Stability Evaluation of the Octapod Sensor Mount

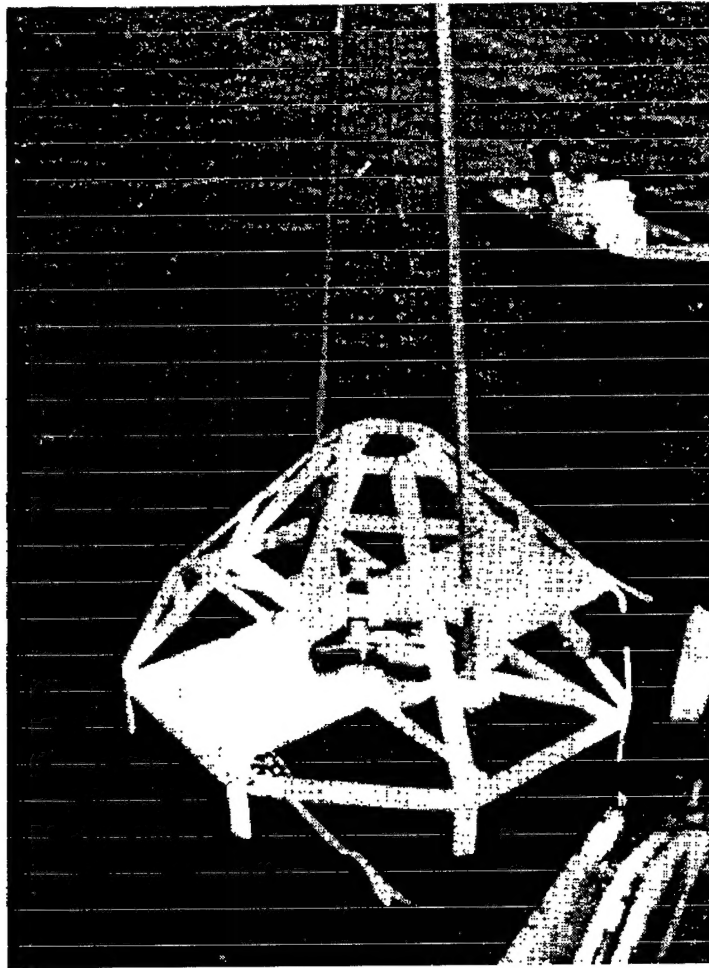
The Octapod (Figure 1) is a 4-ft-tall, eight-sided, heavy steel instrument mount designed by CERC's Prototype Measurement and Analysis Branch (PMAB) to support and protect a variety of oceanographic sensors. The 1-ft-long leg extensions located at each of the eight corners were designed to bury into the bottom to prevent trawler nets from snagging the base plate and entangling the Octapod. Although the design of the Octapod used in this field evaluation has recently been extensively modified to make it more trawler-resistant, the stability results presented herein are still valid.

Figure 1. OCTAPOD being deployed

The modified design is six-sided and 2 to 3 ft tall, depending on application, with 2-ft-long leg extensions.

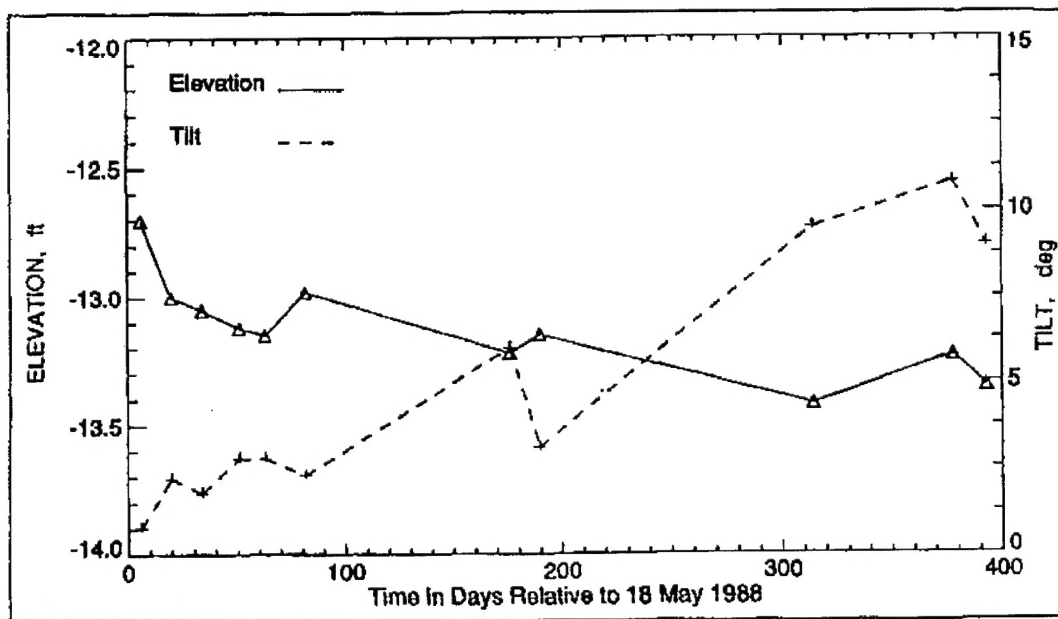
Figure 2. Octapod elevation and tilt

Eleven measurements were made starting on 24 May 1988 (day 6 on the abscissa of Figure 2) and ending on 15 June 1989 (day 394). The measurements were not uniformly distributed through time; over half were taken during the first three months of the study when the greatest amount of settling was expected. Some additional measurements were attempted but could not be made because of high seas. In addition to the measurements of the Octapod, 24 surveys were conducted of profile line 188 located 80 ft to the south. Five of these surveys are shown in Figure 3. Table 2 lists interpolated depths at the position of the Octapod (1,570 ft) and at other nearby locations. Periodic diver inspections were made to observe the Octapod and note any scour or filling that took place.

Table 1 summarizes each of the Octapod measurements. Elevations computed based on each of the prisms compared favorably. Note that the adjusted X and Y coordinates given in Table 1 are for the location of the prisms, not of the Octapod itself. A detailed analysis of the 10 repetitions from each measurement session indicated that by using 10 measurements the tilt of the Octapod could be resolved to 1 deg and the elevation could be resolved to 0.1 ft. The variation in Octapod elevation and tilt are shown in Figure 2. Figure 2 clearly shows the rapid decrease in depth (0.3 ft) which occurred immediately following the first survey, an apparent response to the installation. It also shows the relative stability during

most of the period and the points that indicate upward movement of the Octapod.

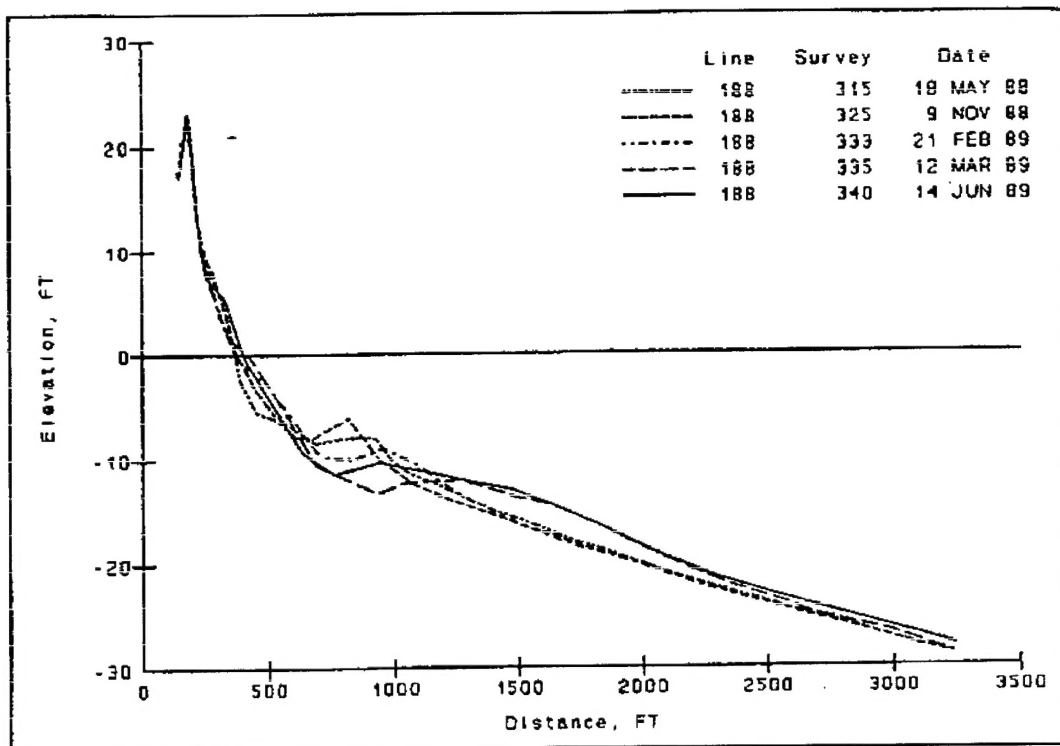
Figure 3. Representative surveys of Profile Line 188 during the study

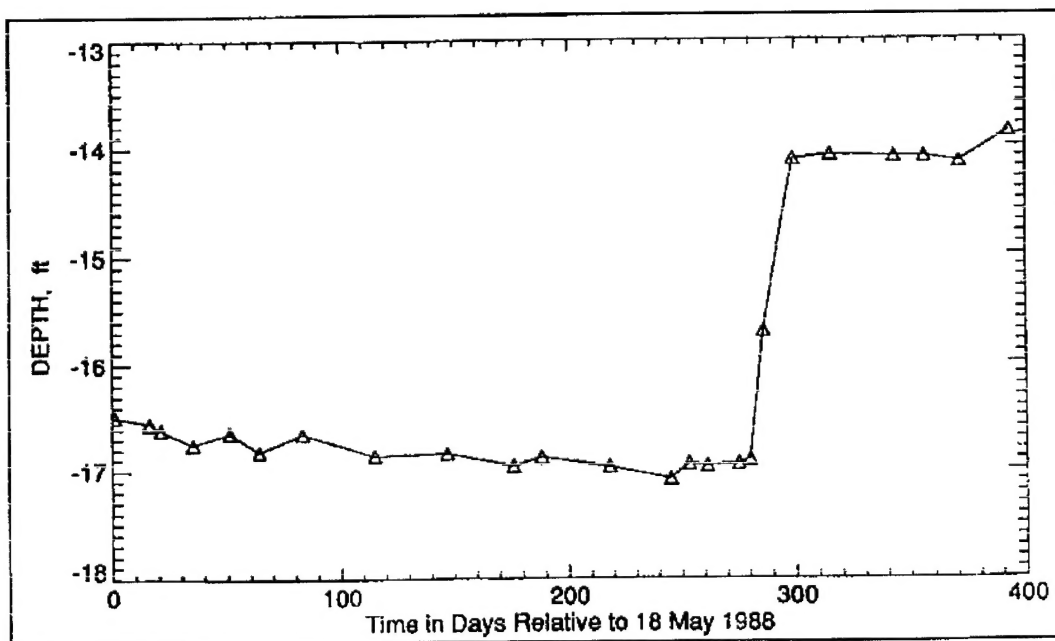
The variations in sea-floor depth at the Octapod are clearly seen in Figure 4 which plots the data in Table 2. The figure shows that at the location of the Octapod the bottom was extremely stable until a sequence of

Figure 4. Variation in depth at the Octapod site

two storms occurred, the first on 24 February 1989 (day 282) and the second two weeks later on 7 March (day 296). Each of these storms moved significant amounts of material offshore, ultimately covering the Octapod with 2.7 ft of sediment.
